Energy Efficient Initiative – Installation of Active Harmonic Filter and Real Time Capacitor Bank in High Speed Lift System

Ir K F Yee

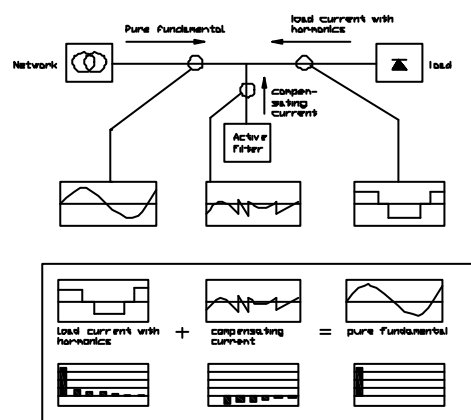
Figure 2 - Working Principle of Active Harmonic Filter

Active Harmonic Filter is based on the principle with a real-time measuring device and will actively generate a harmonic current spectrum in opposite phase to the measured distorting harmonic current for cancellation. **Fig 2** shows the working principle of AHF:

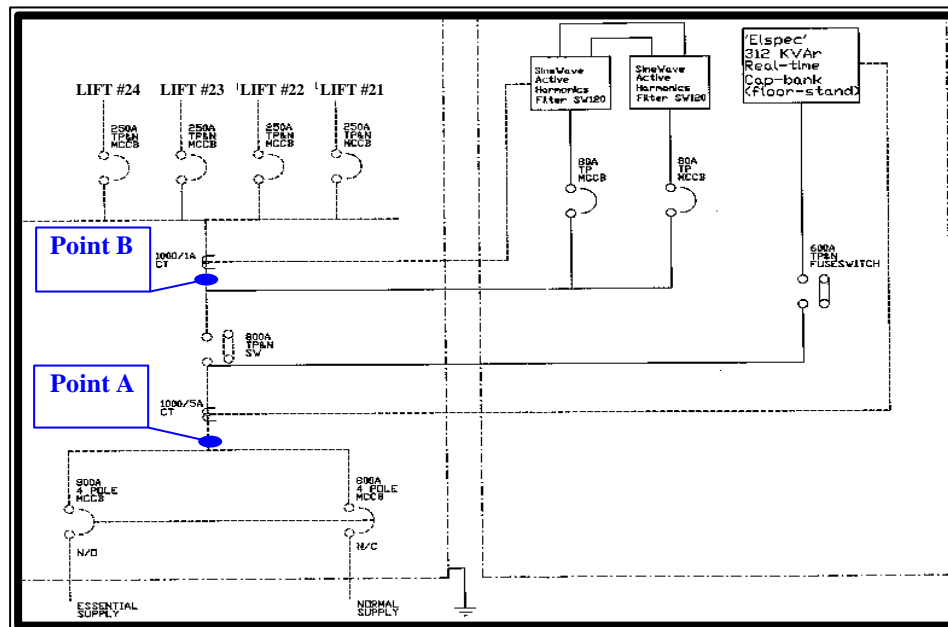
In order to monitor the harmonic distortion and power factor in the system, two sets of CM4000 Power analyzer were installed at **Point A** and **Point B** (as shown in the simplified schematic diagram below) for data logging at 1-minute intervals for 7 consecutive days.

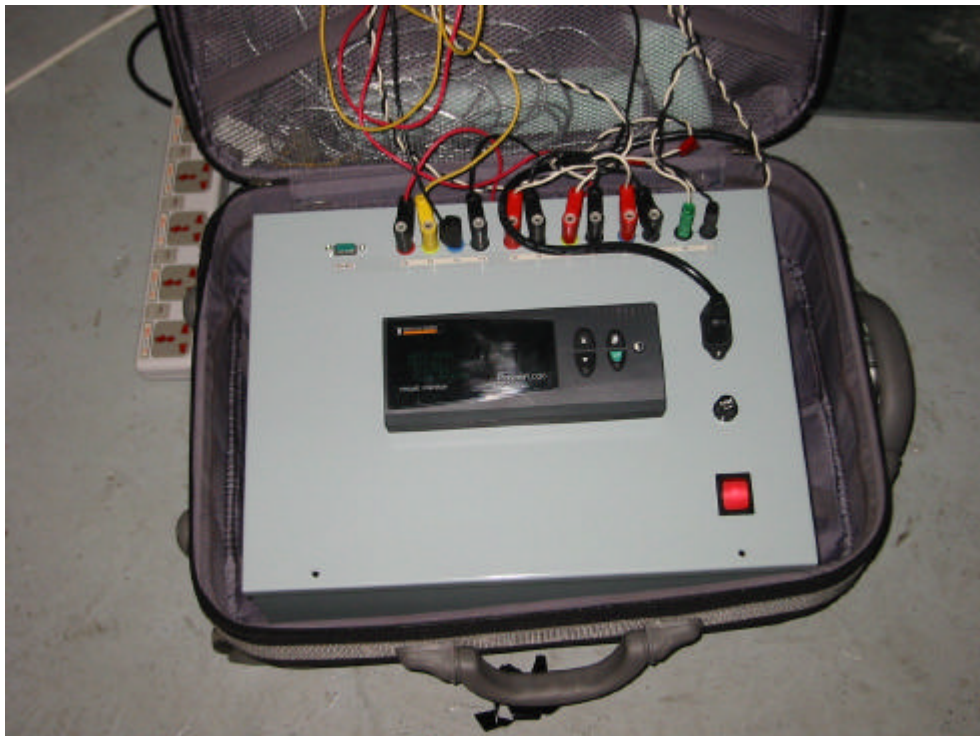
Photo#2 - Measuring Equipment (CM4000)

The Power Analyzer (Schneider - Square D Portable Circuit Monitor CM4000) and software (Schneider - Square D Management Software SMS3000) were used for on-site measurement.

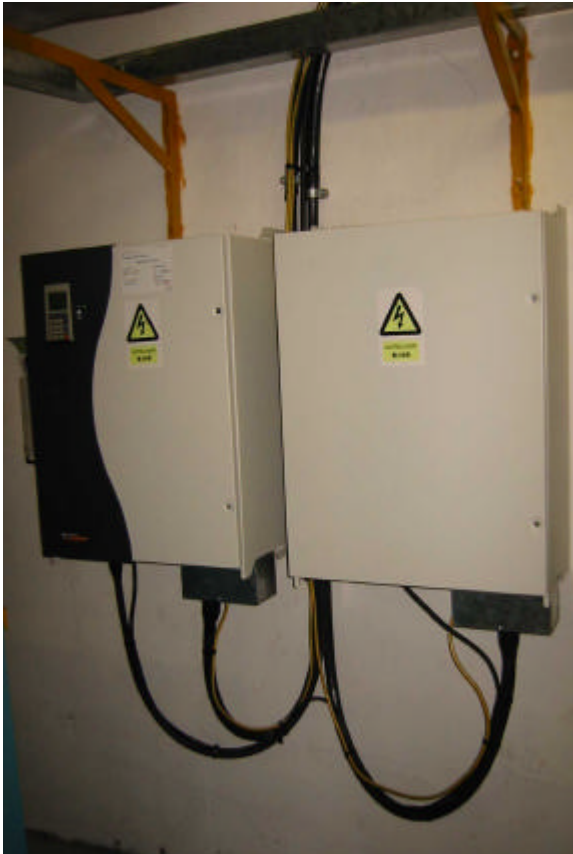
Photo#3 – Active Harmonic Filter

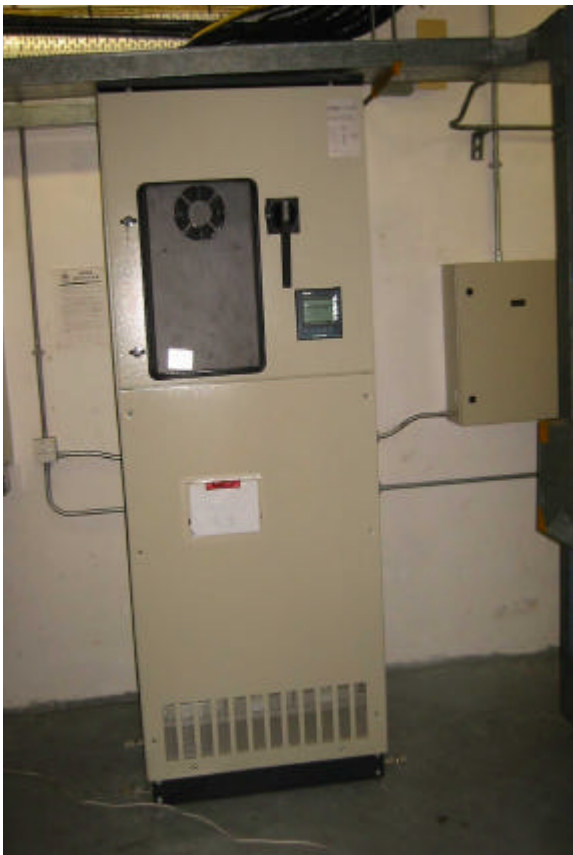
Photo#4 – Real Time Capacitor Bank

The device is principally intended to provide reactive power for power factor correction. In practice, the network characteristics to allow for a correct sizing of power factor correction bank should be well known in advance. Some data were extracted and recorded, from which the extreme cases were summarized as follows:

From sampling data collected and analyzed, a **300kVar** power factor correction bank was selected.

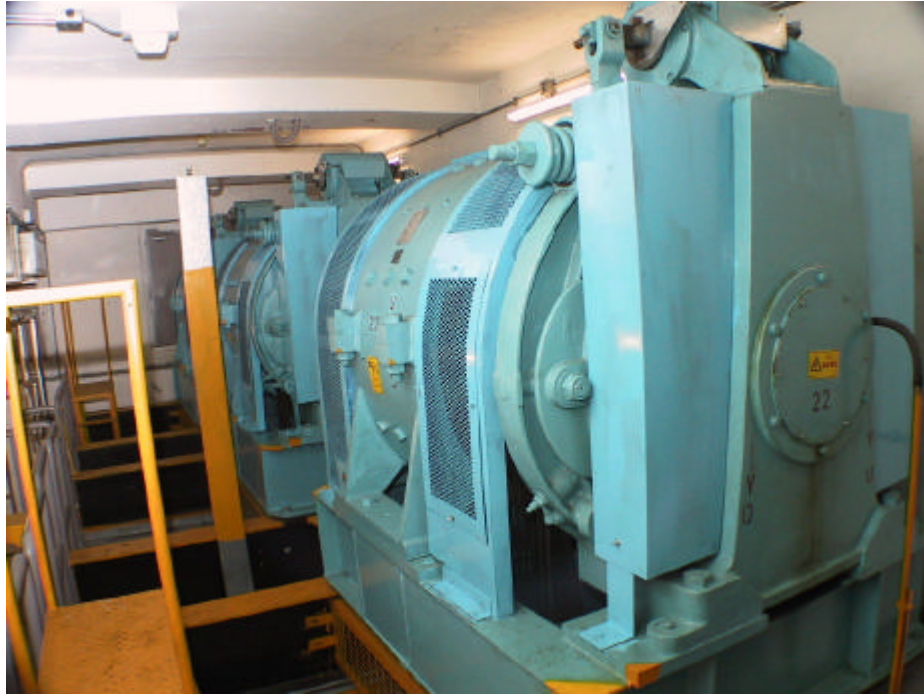
Photo#5 – Lift Motor Drives

The lift system under test was a thyristor-controlled type equipped with a typical 6-pulse thyristor bridge. Analysis showed that the dominant distortions occurred at 5th, 7th, 11th and 13th order respectively. Obviously, the measured THD_I from 20% to 40% above failed to comply with the recommended standard.
